EXPERIENCES on HILTON HEAD ISLAND

Christopher G. Creed, P.E.
olsen associates, inc.

Hilton Head Island Beach Project History

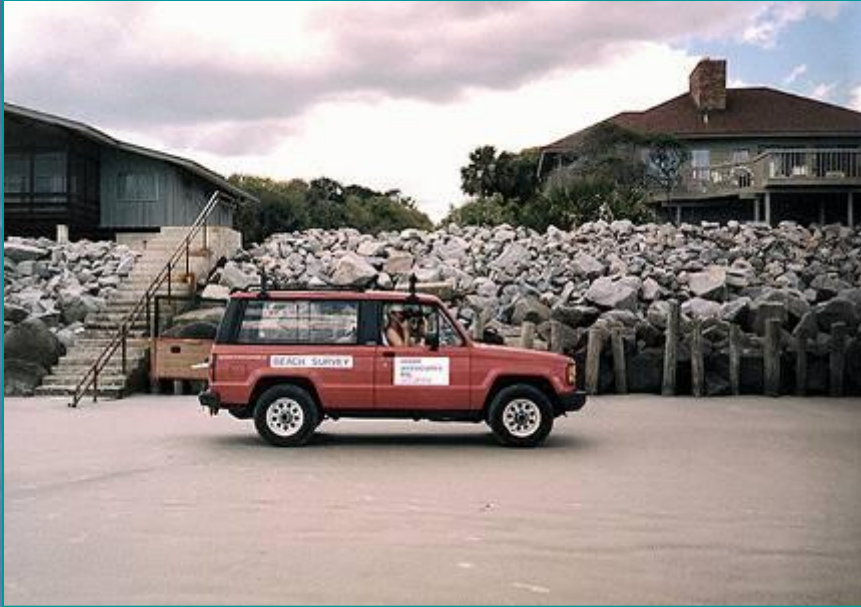
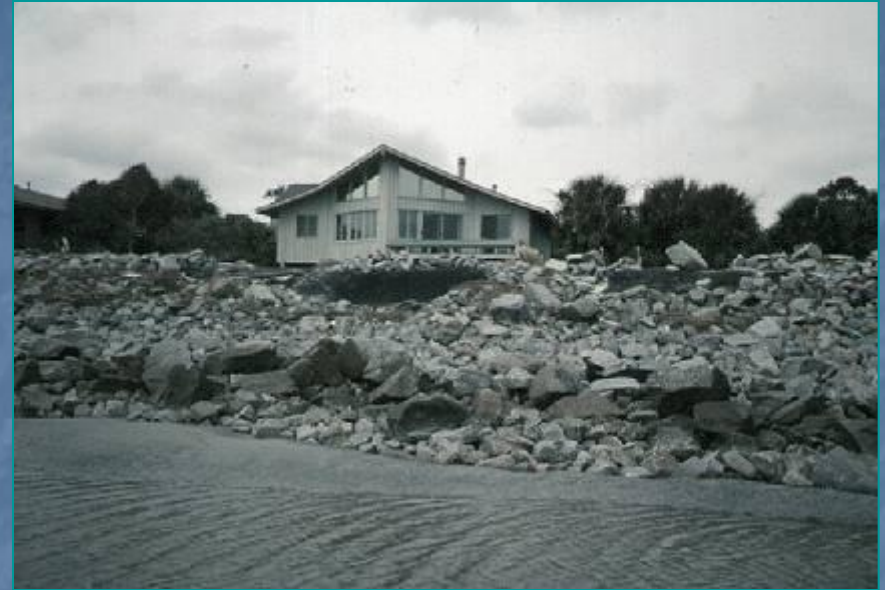
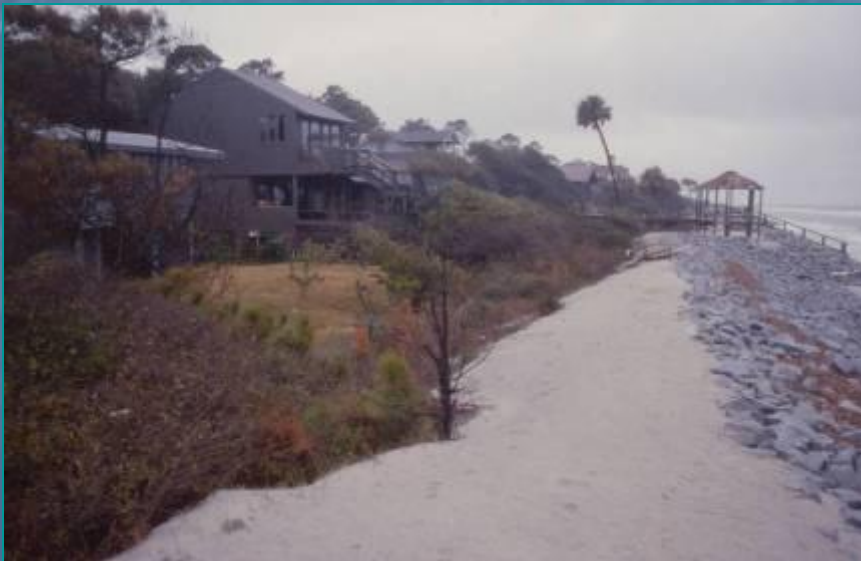
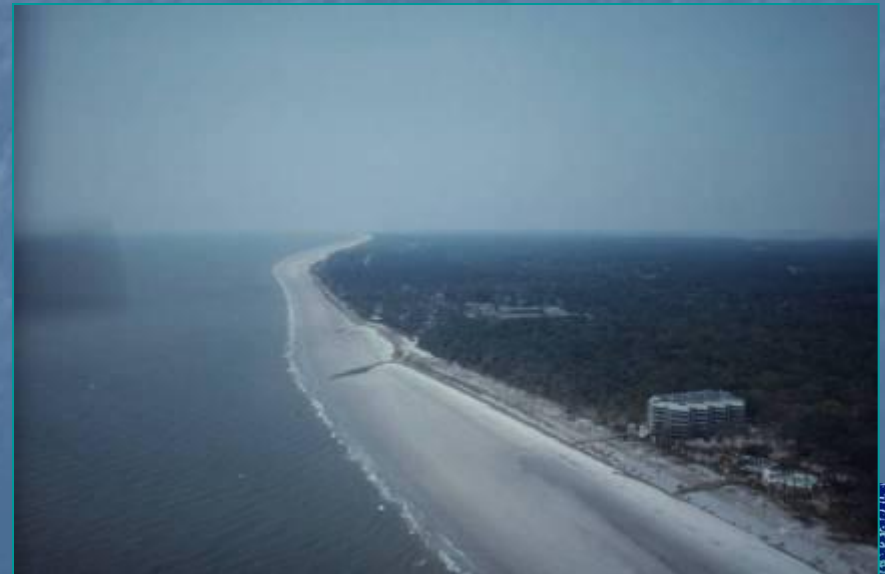
Mid-1980 Beach Conditions

Mid-1980 Beach Conditions/Issues

- Areas of Highly Erosional Shoreline
- Chronic Sediment Deficit (northern 2/3)
- Need for Comprehensive Protection of Upland
- Minimal Dry Beach
(over 9,000 feet of oceanfront armoring)
- Potential Federal navigation project impacts from Port Royal Sound (PRS)

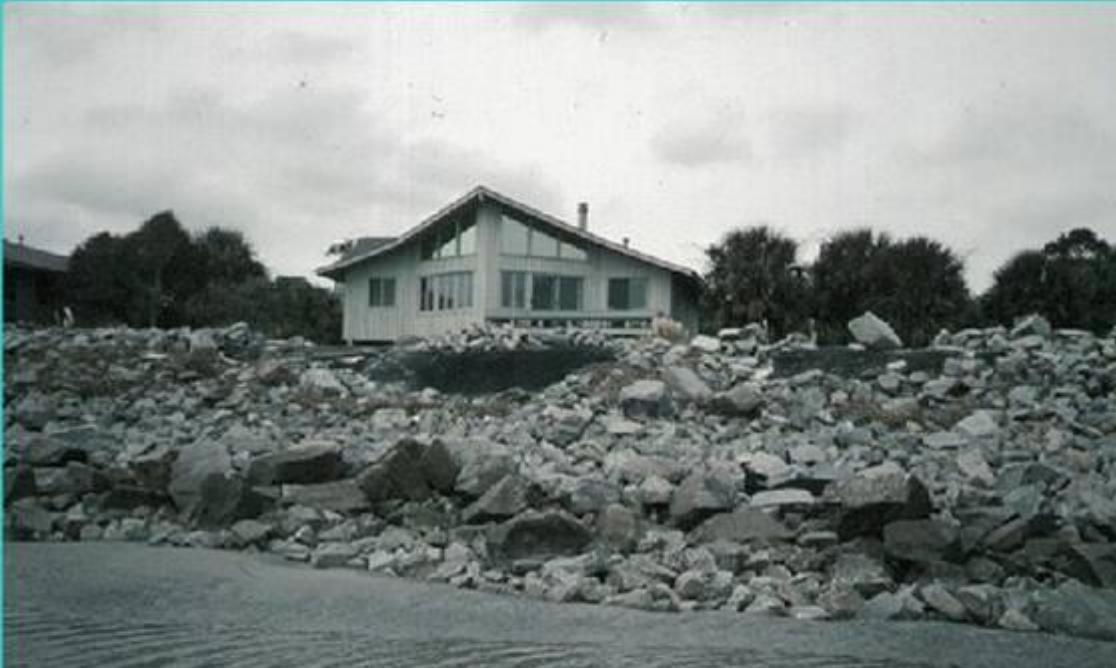
1989 (Typical low tide condition at North Forest Beach.)

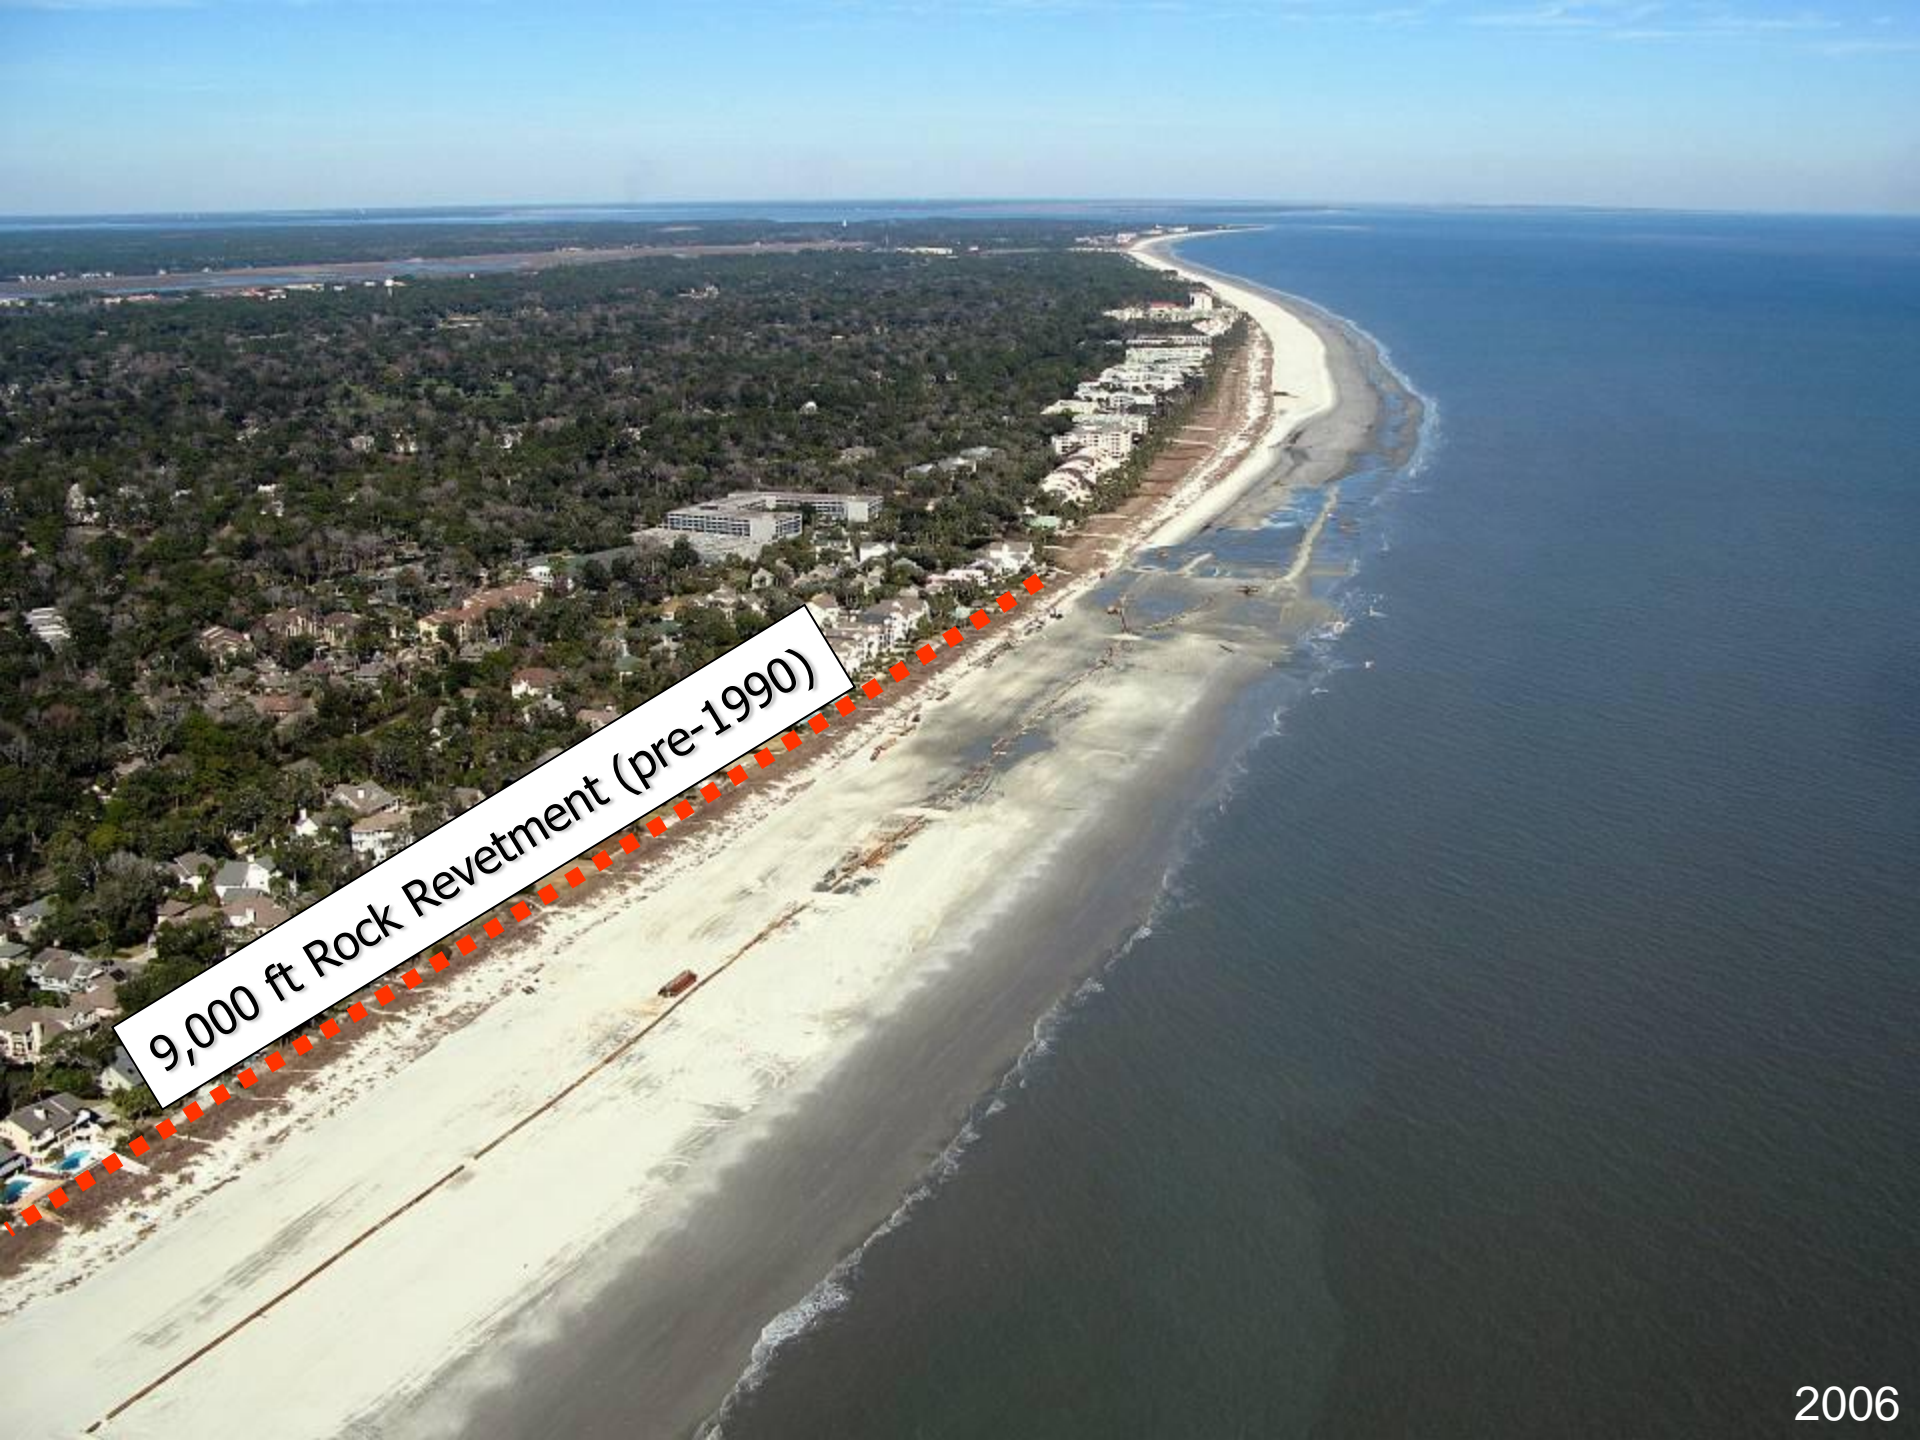
9,000 ft Rock Revetment (pre-1990)
